RESOLUTION NO. 2020-398

A RESOLUTION REQUIRING SAN MIGUEL CORPORATION (SMC) AND THE ENGINEERING EQUIPMENT INCORPORATED (EEI) TO SUBMIT A COMPLETE INVESTIGATION REPORT ON THE INCIDENT THAT TRANSPIRED ON NOVEMBER 21, 2020 AT THE SKYWAY EXTENSION PROJECT, EAST SERVICE ROAD IN BARANGAY CUPANG, MUNTINLUPA CITY.

**SUBJECT:** CRANE ACCIDENT AT SKYWAY SUCAT-ALABANG EXPANSION PROJECT

## INCIDENT SCHEMATIC DIAGRAM

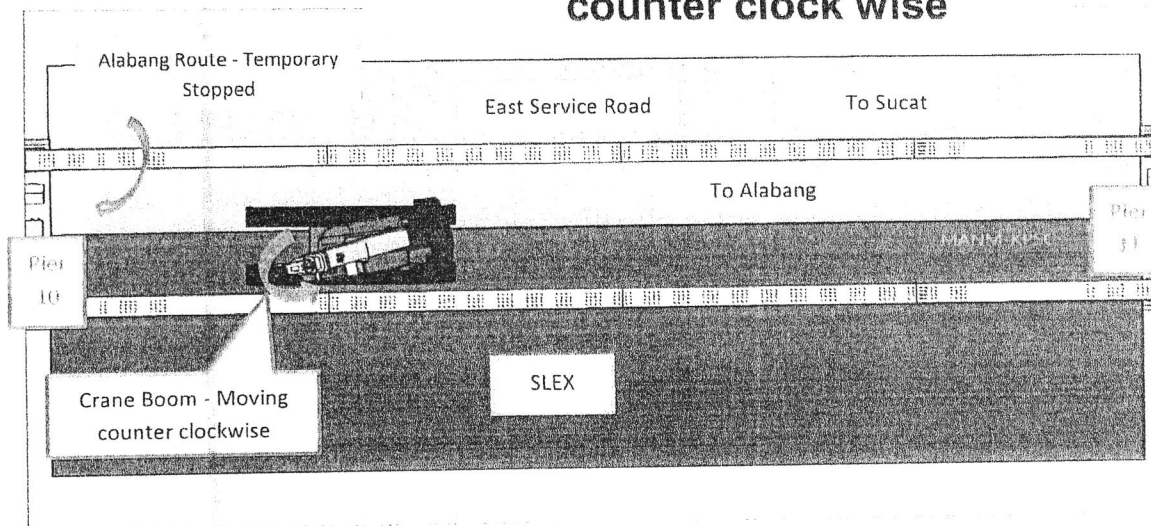
## 2. Crane boom starts rotating counter clock wise

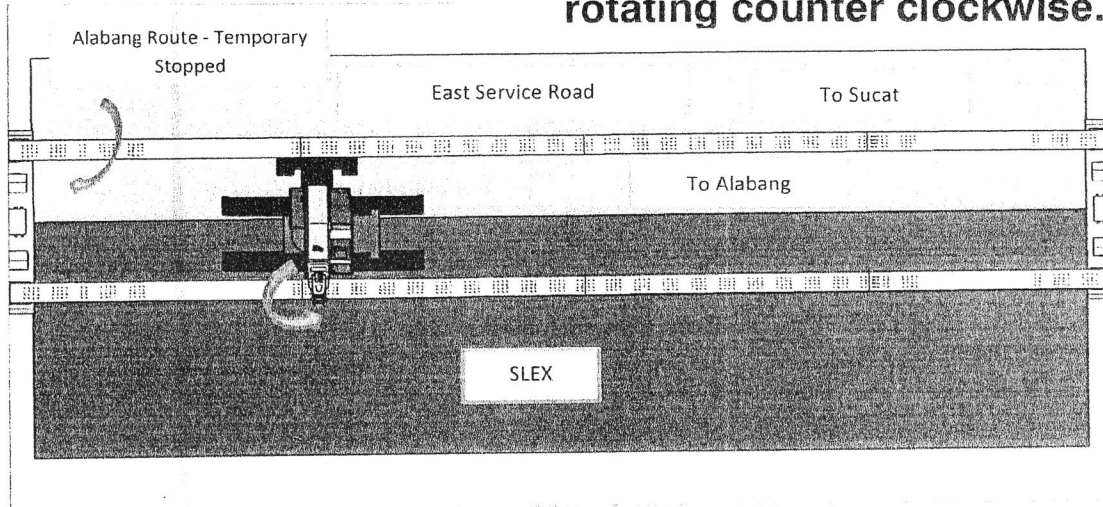
### 3. Crane Boom continuous rotating counter clockwise.

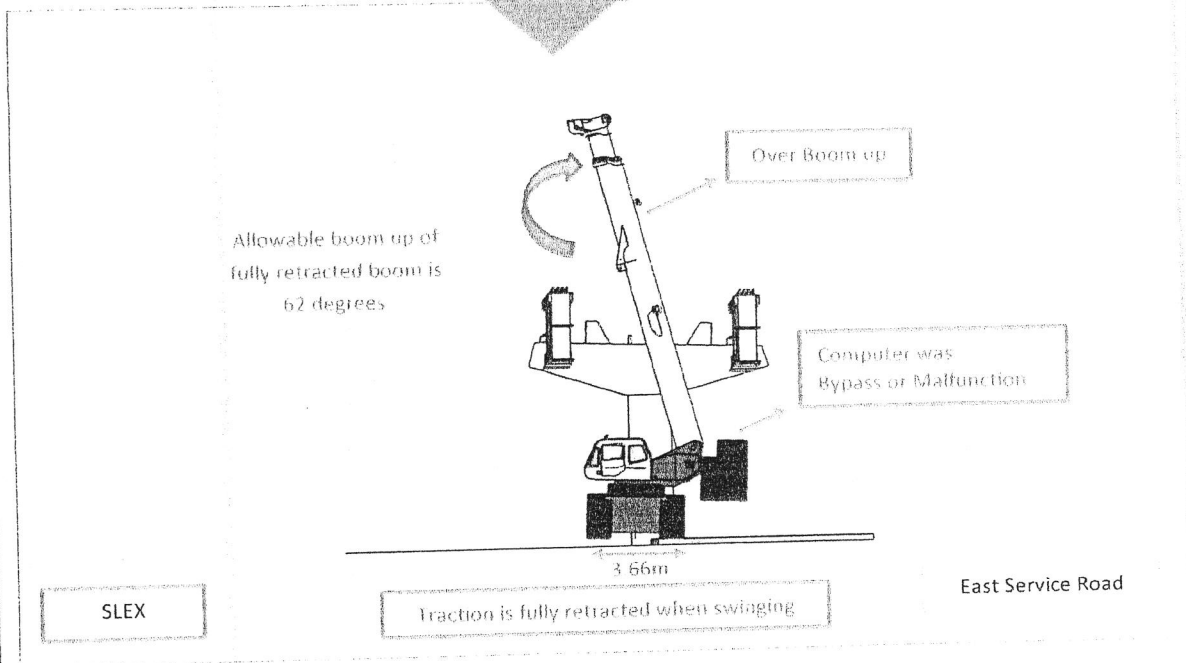
### 4. Crane boom angle approx. 62 degrees upon rotating.

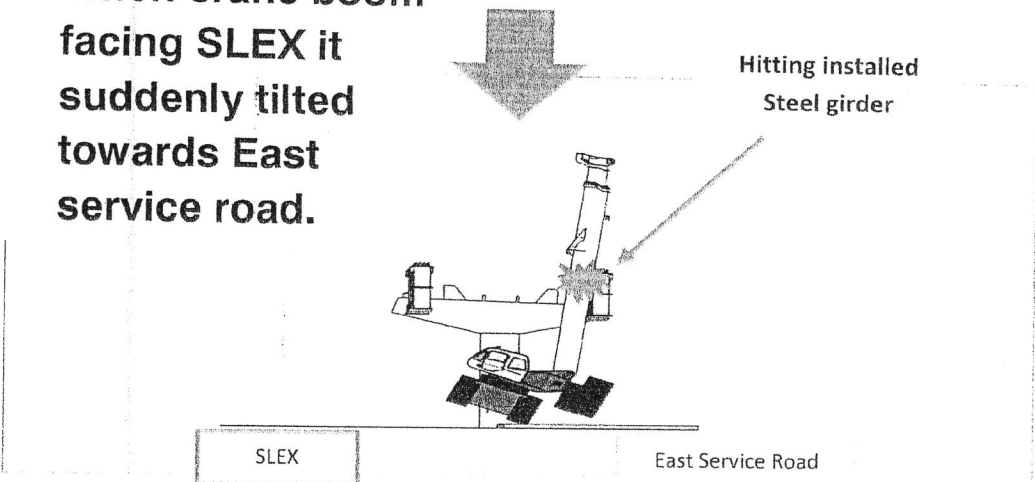
The crane cabin swiveled to its side (counter-clockwise) with the boom at an overextended angle and with tracks unextended, causing the crane and boom to tilt, thus hitting the steel girder along the North-bound service road. The girder fell due to the excessive force from the telescopic boom of the crane.

5. When crane boom facing SLEX it suddenly tilted towards East service road.

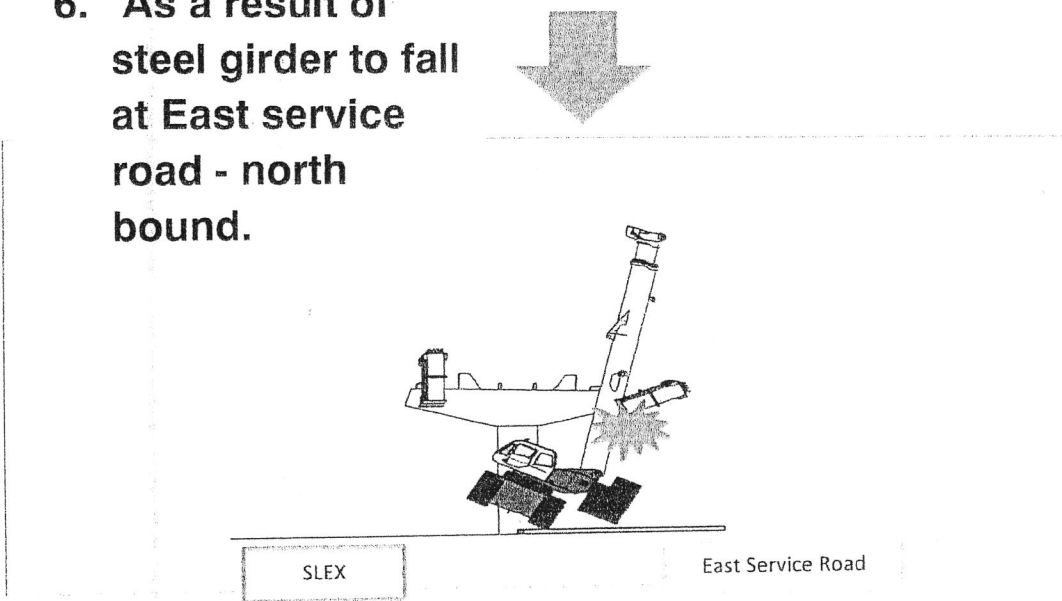
6. As a result of steel girder to fall at East service road - north bound.

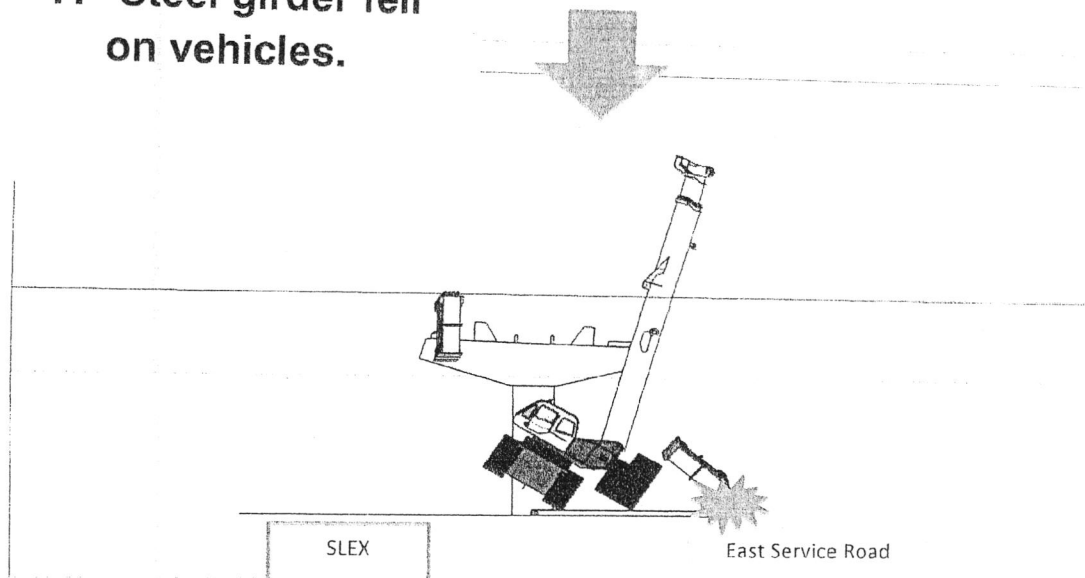
**7. Steel girder fell  
on vehicles.**
